# FEASIBILITY OF ALTERNATIVES TO THE GOAT ROCK STATE BEACH JETTY FOR MANAGING LAGOON WATER SURFACE ELEVATIONS

Prepared for  
Sonoma County Water Agency

March 10, 2017

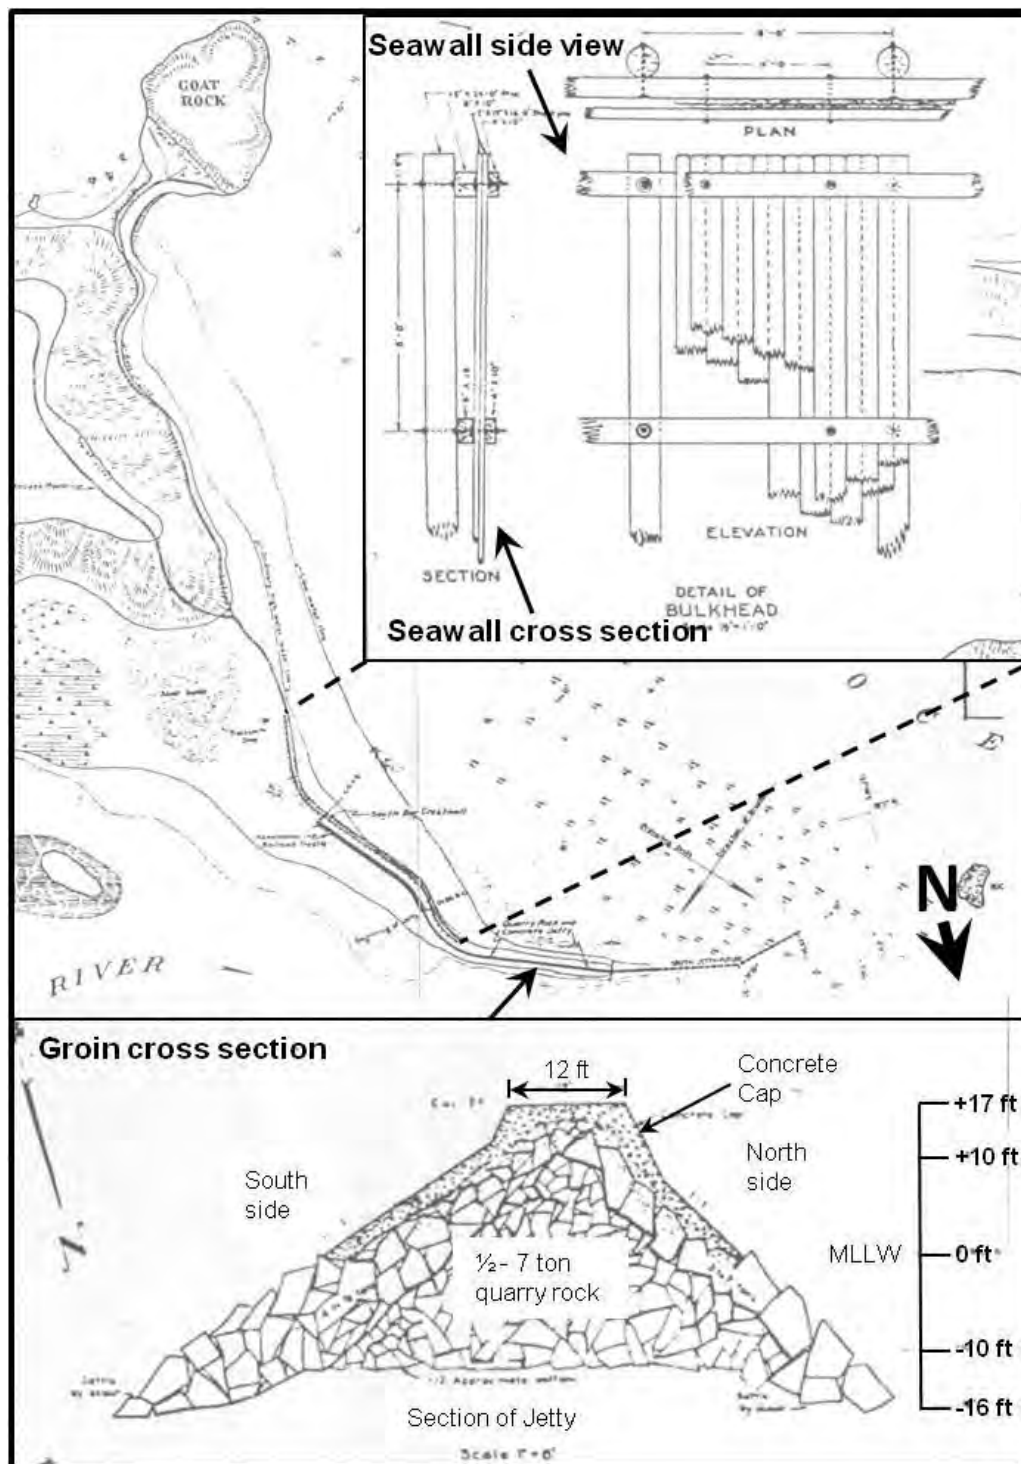
Goat Rock Jetty Feasibility Study . D211669.00  
**Figure 2-1**  
 1938 planning document with detail of the seawall and groin cross section.

SOURCE: DWR (1938), as reproduced in Johnson (1959)

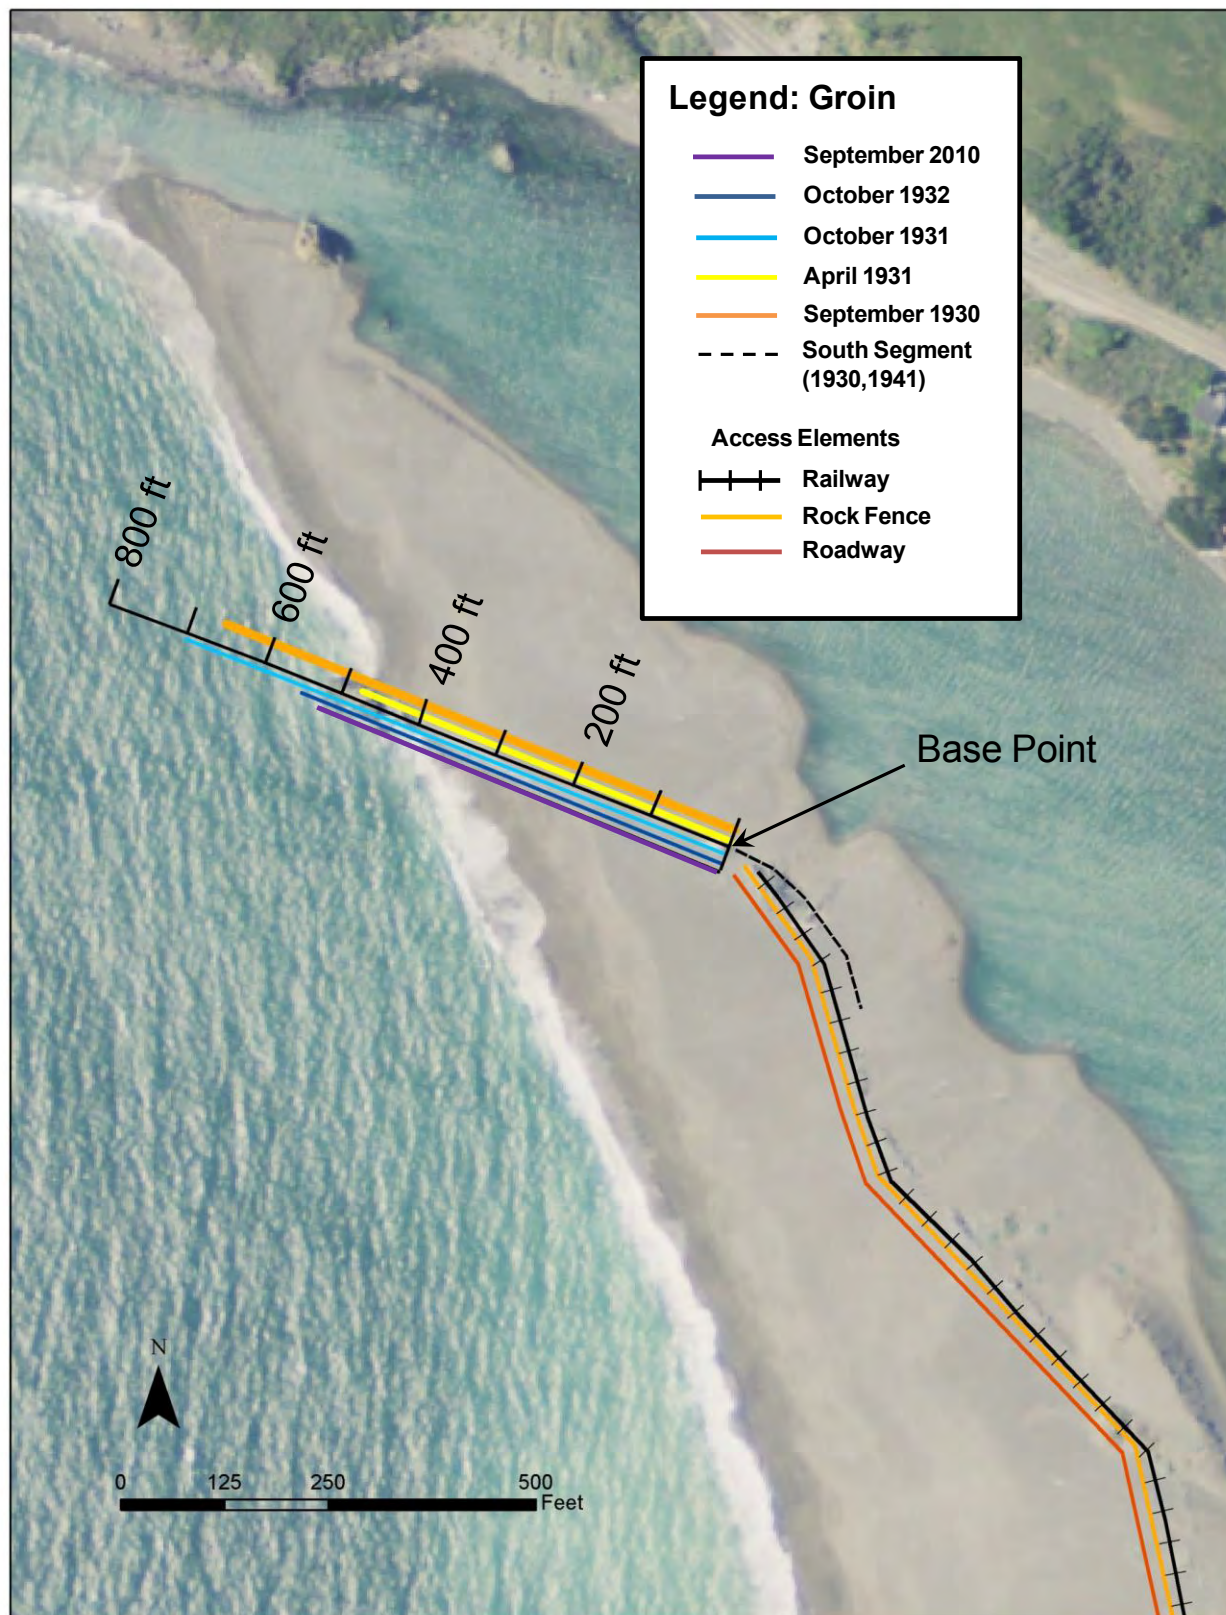
Goat Rock Jetty Feasibility Study . D211669.00  
**Figure 2-2**  
 Plan view of groin construction: 1930-32

SOURCE: NAIP 2007 aerial image of Sonoma County. Construction diagrams are based on a DWR map provided by Johnson (1959) and historical information from Schulz (1942).

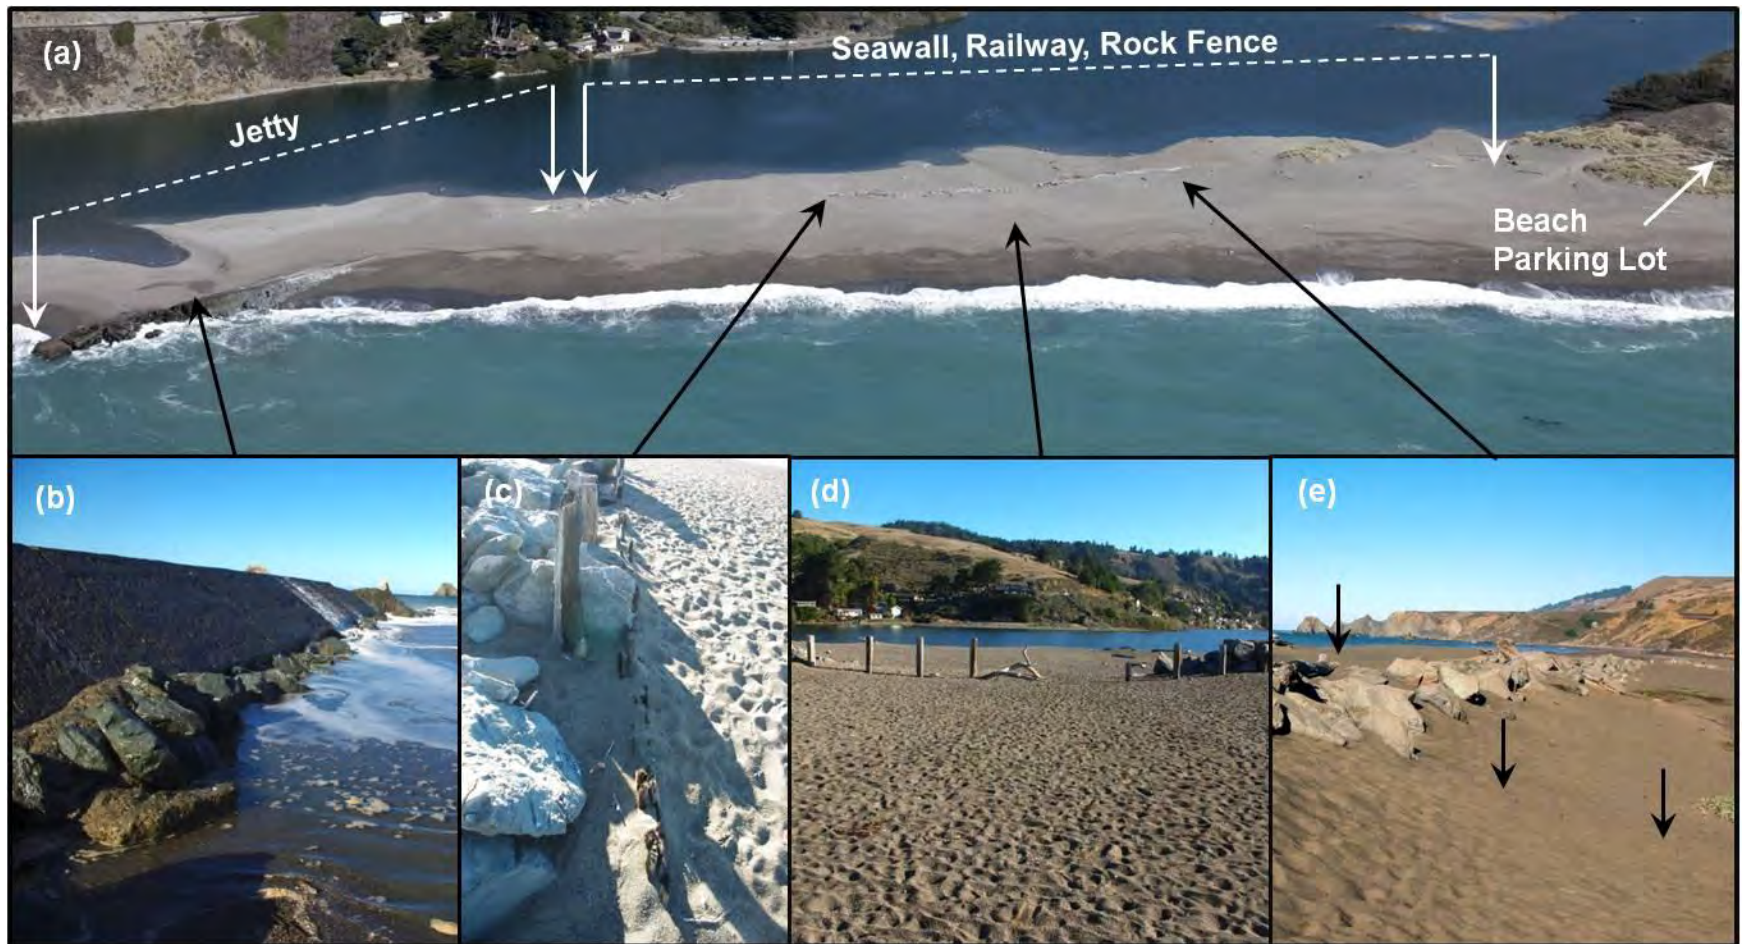
NOTE: Beach visitor parking lot located at far right edge of (a). (b) is a detail of the northern edge of the groin, showing the top of the armor added in 1948. (c) shows the double-layer redwood sheets protruding through the beach. (d) is a wave washover fan where roadway, seawall and railway elements have been destroyed. In (e), note the difference in beach elevation at either end of remaining rock fence, indicating deposition of wave overwash on the ocean side.

Detail of the present-day jetty complex (a), with insets of (b) the groin structure, (c,d) seawall elements, and (e) the rock fence.

The original seawall and rock fence (Figure 1-1) are exposed in some areas, with some of the vertical posts shown in Figure 2-4d and the redwood sheeting shown in Figure 2-4c. The groin and remaining access elements have been degrading since their original construction. The ongoing degradation of the groin is particularly visible in ground-based photographs taken in different years (Figure 2-7). Degradation of the access elements is visible in the available series of aerial photographs used to assess the historical changes in beach morphology (see Section 5). The roadway is no longer visible in aerial photographs taken after 1945. Parts of the rock fence and the portion of the groin south of the base point show signs of degradation starting in 1965.

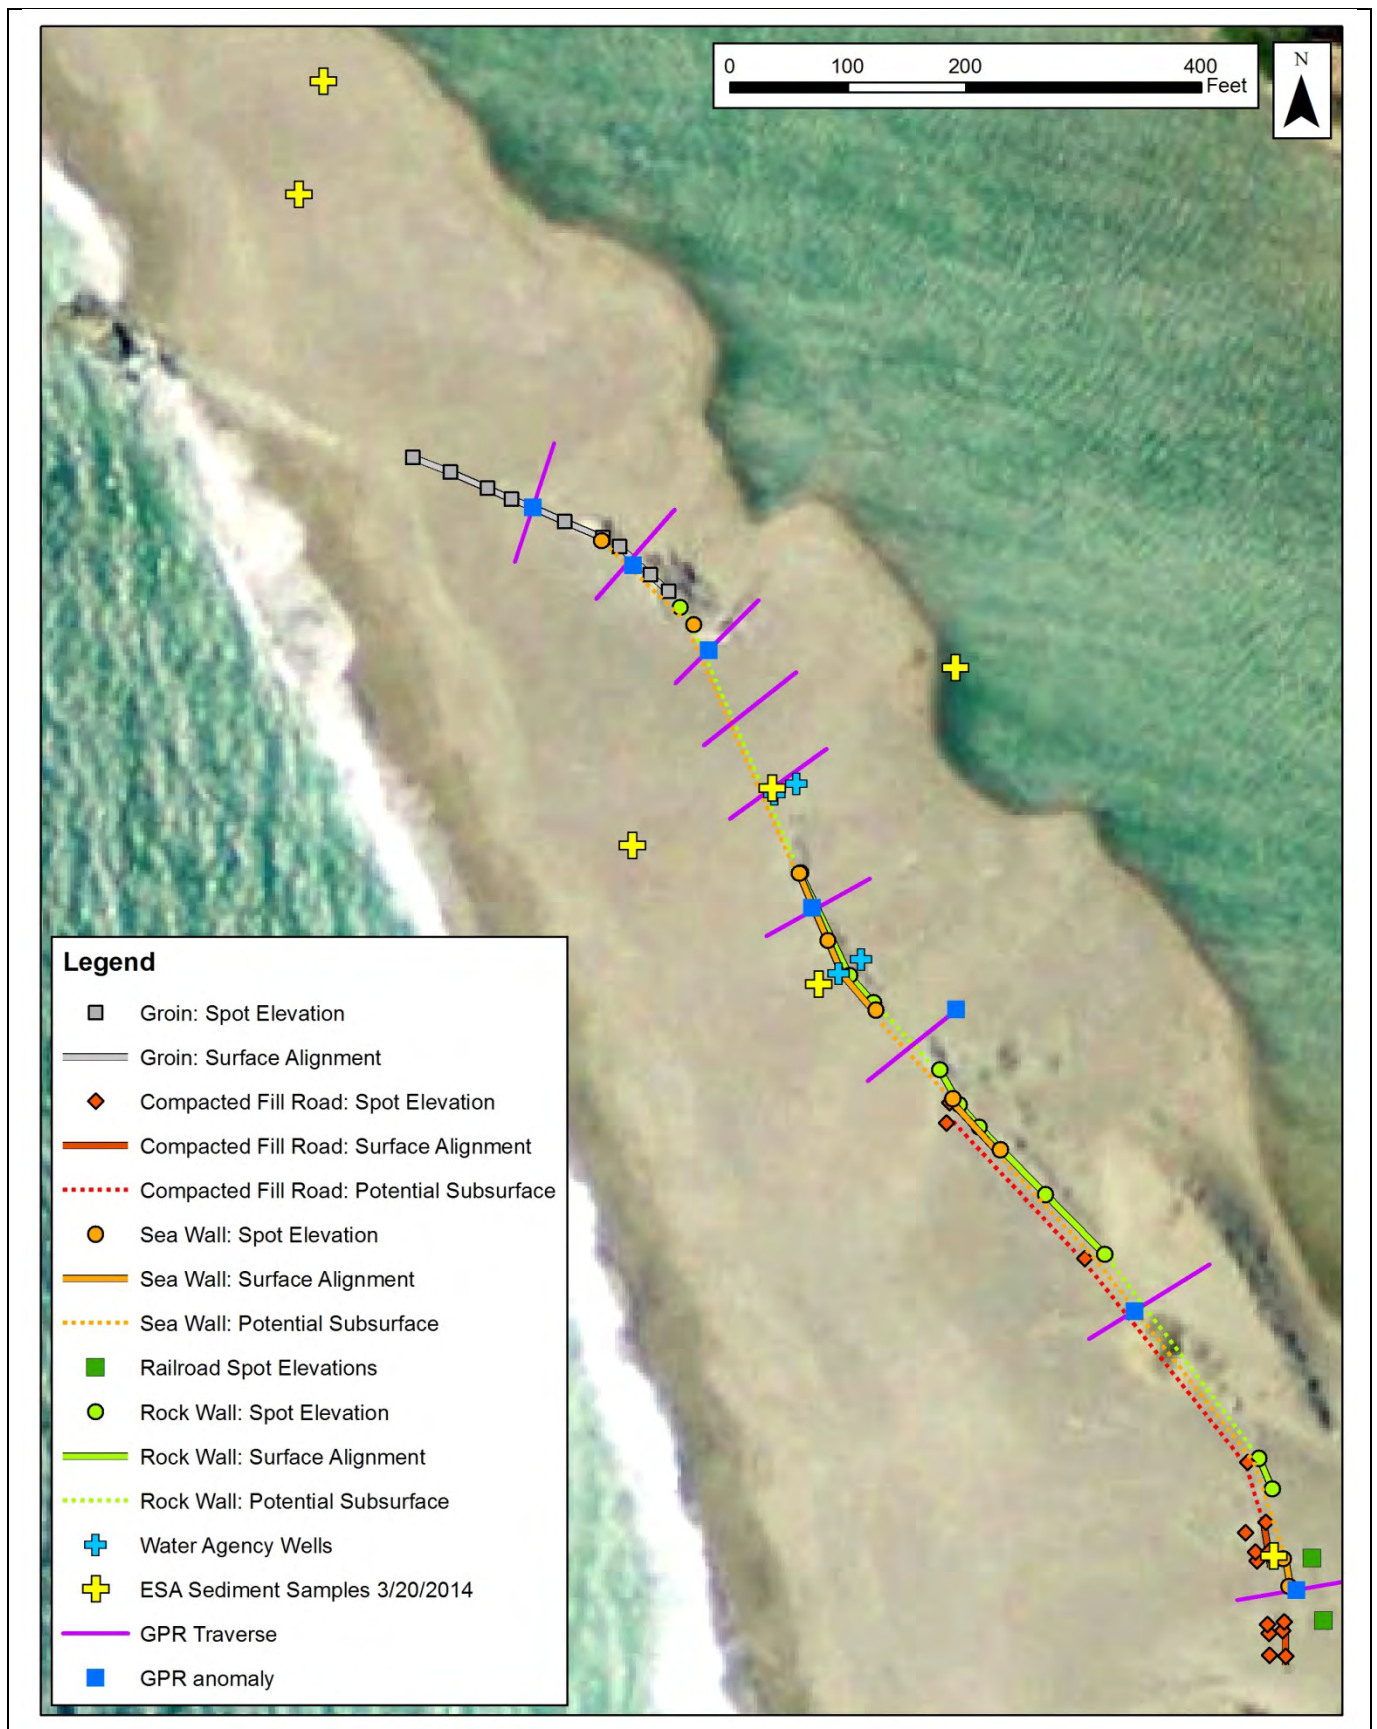
**Figure 2-5**  
Plan view of jetty elements

SOURCE: NAIP 2007 aerial image of Sonoma County.  
GPR traverses and anomalies are based on Plate 3 of NORCAL (2015)

Assessment of the subsurface with ground-penetrating radar (NORCAL, 2015) indicated the jetty is in various states of degradation along its length (Figure 2-5). In addition to the places where jetty elements are visible at the surface and persist with depth, the ground-penetrating radar detected jetty elements under several feet of sand even where there was nothing visible on the surface. In one instance, the subsurface jetty material was displaced more than thirty feet inland from the jetty's original alignment, probably due to wave action. At two transects, the ground-penetrating radar did not

- **Buried jetty elements:**
  - GPR surveys indicate the seawall may have deteriorated and is absent in the beach in areas where it is not visible at the surface (Figure 2-5).
  - GPR surveys suggest the concrete cap is degraded but still in place in buried portions of the groin

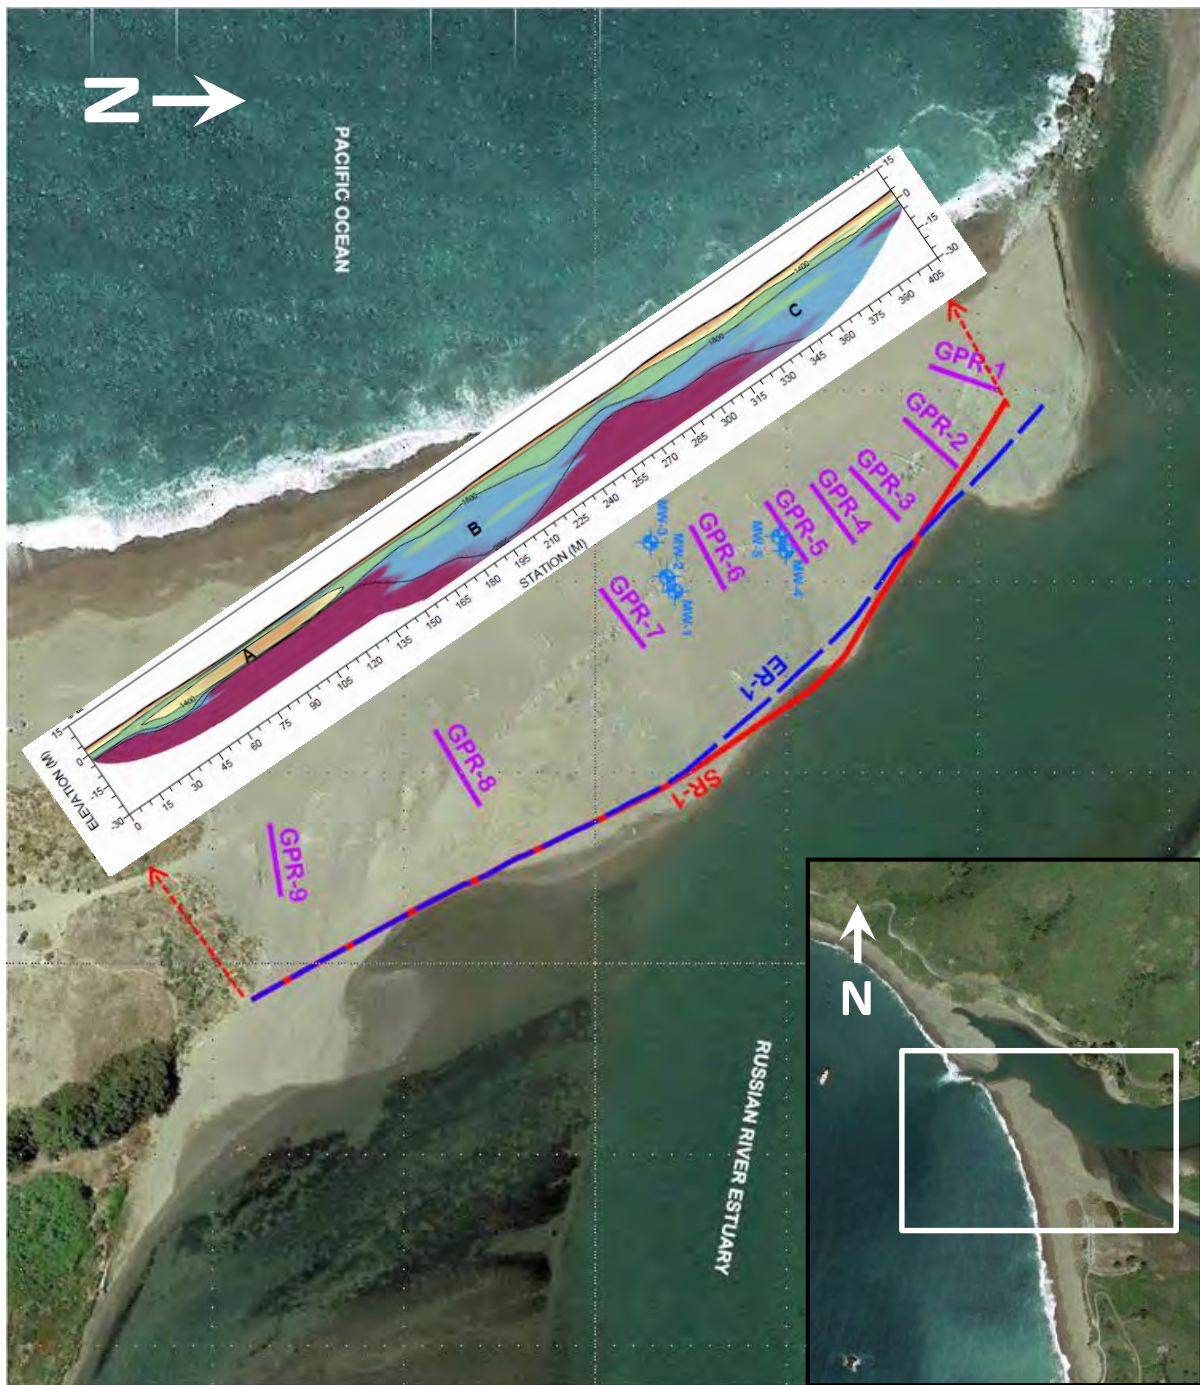
**Figure 3-1**  
Seismic refraction data collected south of the jetty groin.

SOURCE: LBNL (2015). Data collected by NorCal Geophysics

The seismic refraction survey conducted by NORCAL detected a zone of low seismic velocity in a 300-ft stretch of the beach berm just north of the Beach Parking Lot (Figure 3-1). They attribute the low seismic velocity to dissolved gases released by decaying organic material in the layer, which spans elevations from about 0 to -15 ft NGVD. We interpret this buried organic layer as consisting of former marsh. Currently, vegetated marsh is present just to the east and southwest of the buried organic layer. When sea levels were lower due to the last ice age, it is likely that the buried organic layer was contiguous with the predecessors of the current marsh and extended underneath the current location of the beach berm. In response to sea level rise caused by retreating glaciers, the beach berm transgressed landward and upward, burying the former marsh. Historic maps and photographs (Figure 5-2, top row) show beach sands transgressing landward in this portion of beach before being anchored by beach grasses. To form an organic layer this thick probably required persistent and undisturbed marsh vegetation that gradually accreted upward in response to sea level rise. The seismic survey detected bedrock directly below the organic layer and at considerably higher elevation than the bedrock surface to the north. This stratigraphy of elevated bed rock, organic layer extending from east to west, and beach sands transgressing from west to east leaves little room for the river mouth previously occupying this area. Coring and dating might further clarify the contents and geomorphic history of these layers.

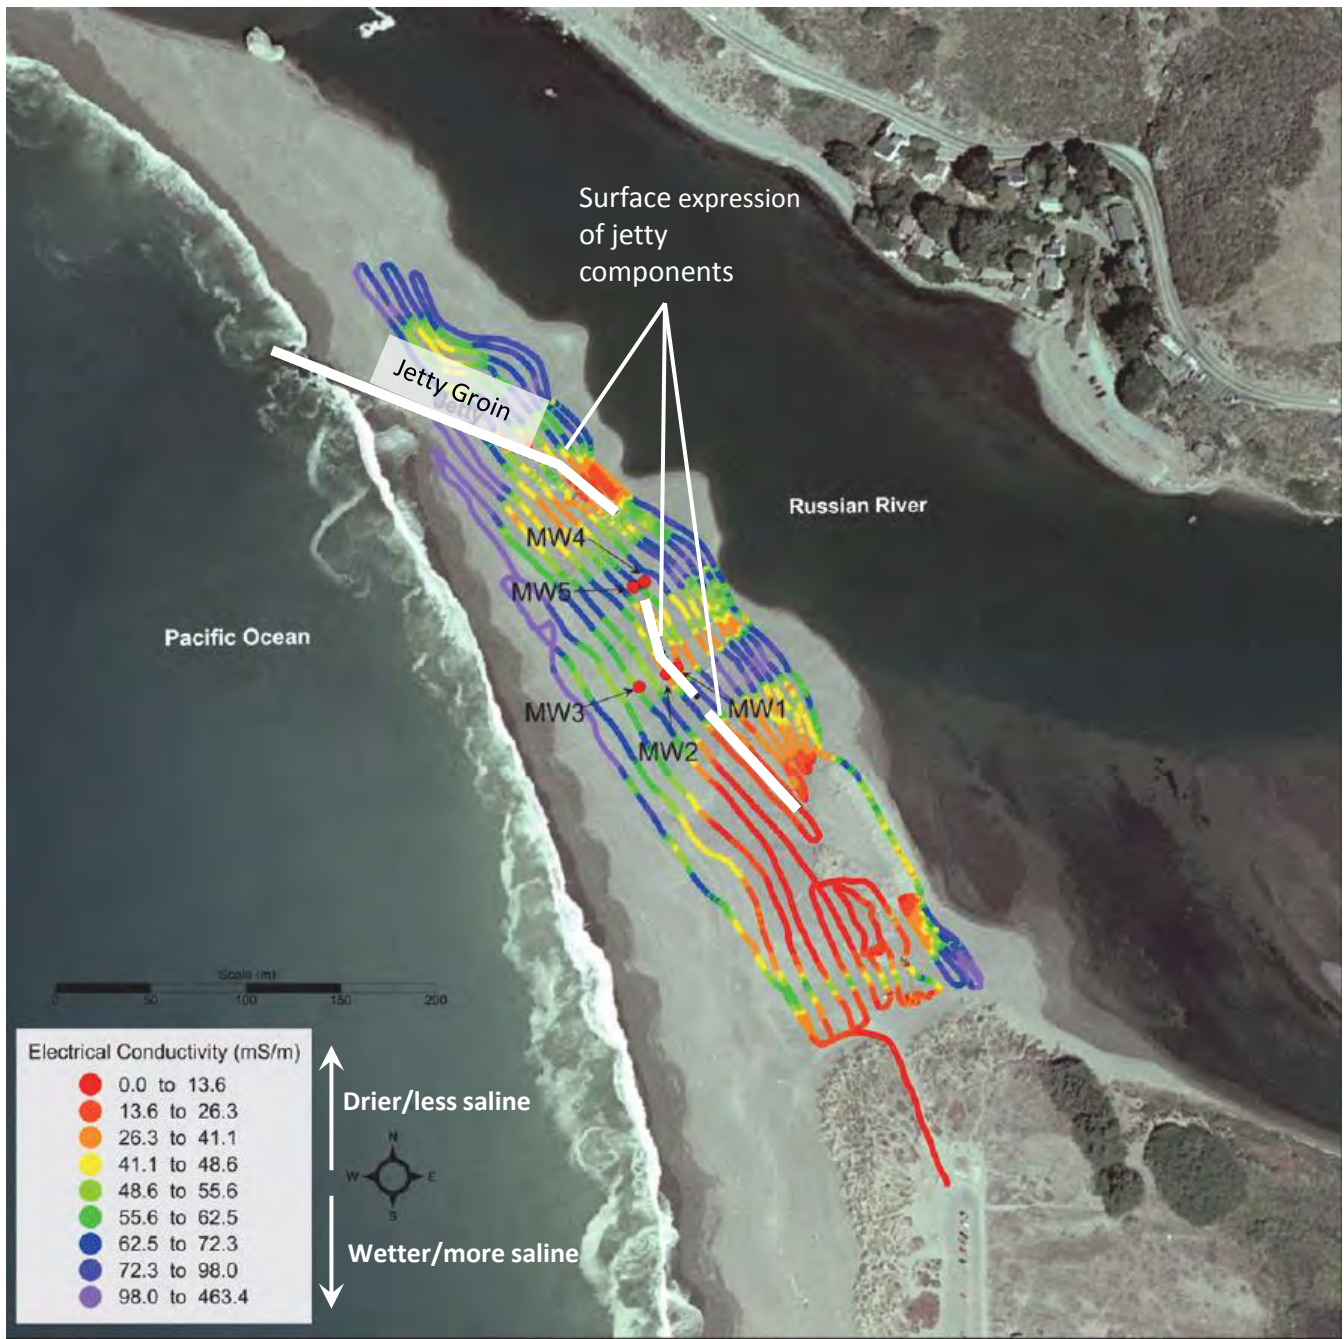
SOURCE: LBNL (2015)

- **Bedrock** (Figure 3-1):
  - The surface of the bedrock below the beach is highest immediately north of the Beach Parking Lot (approx. -15 to -30 feet NGVD).

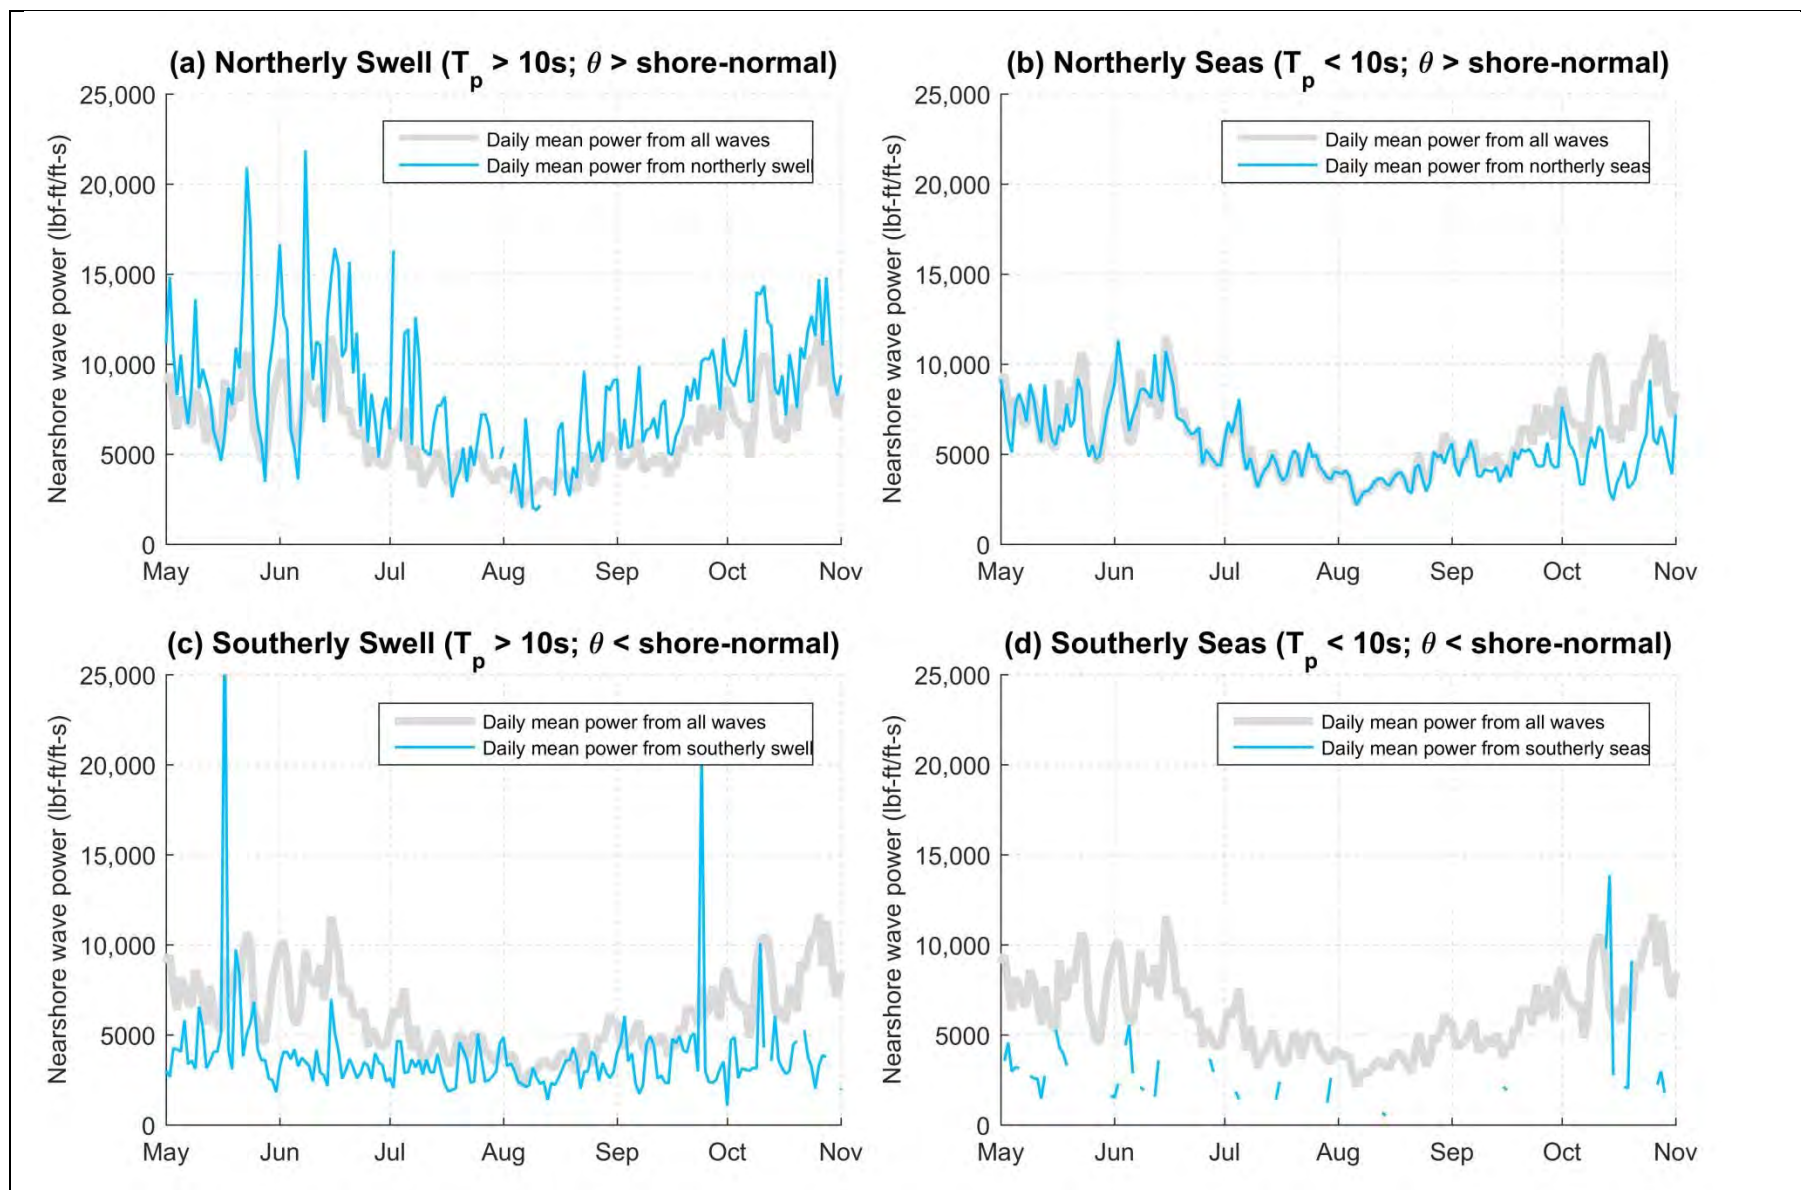
Daily aggregated measurements of offshore (Pt. Reyes) wave power grouped by northerly and southerly swells and seas.

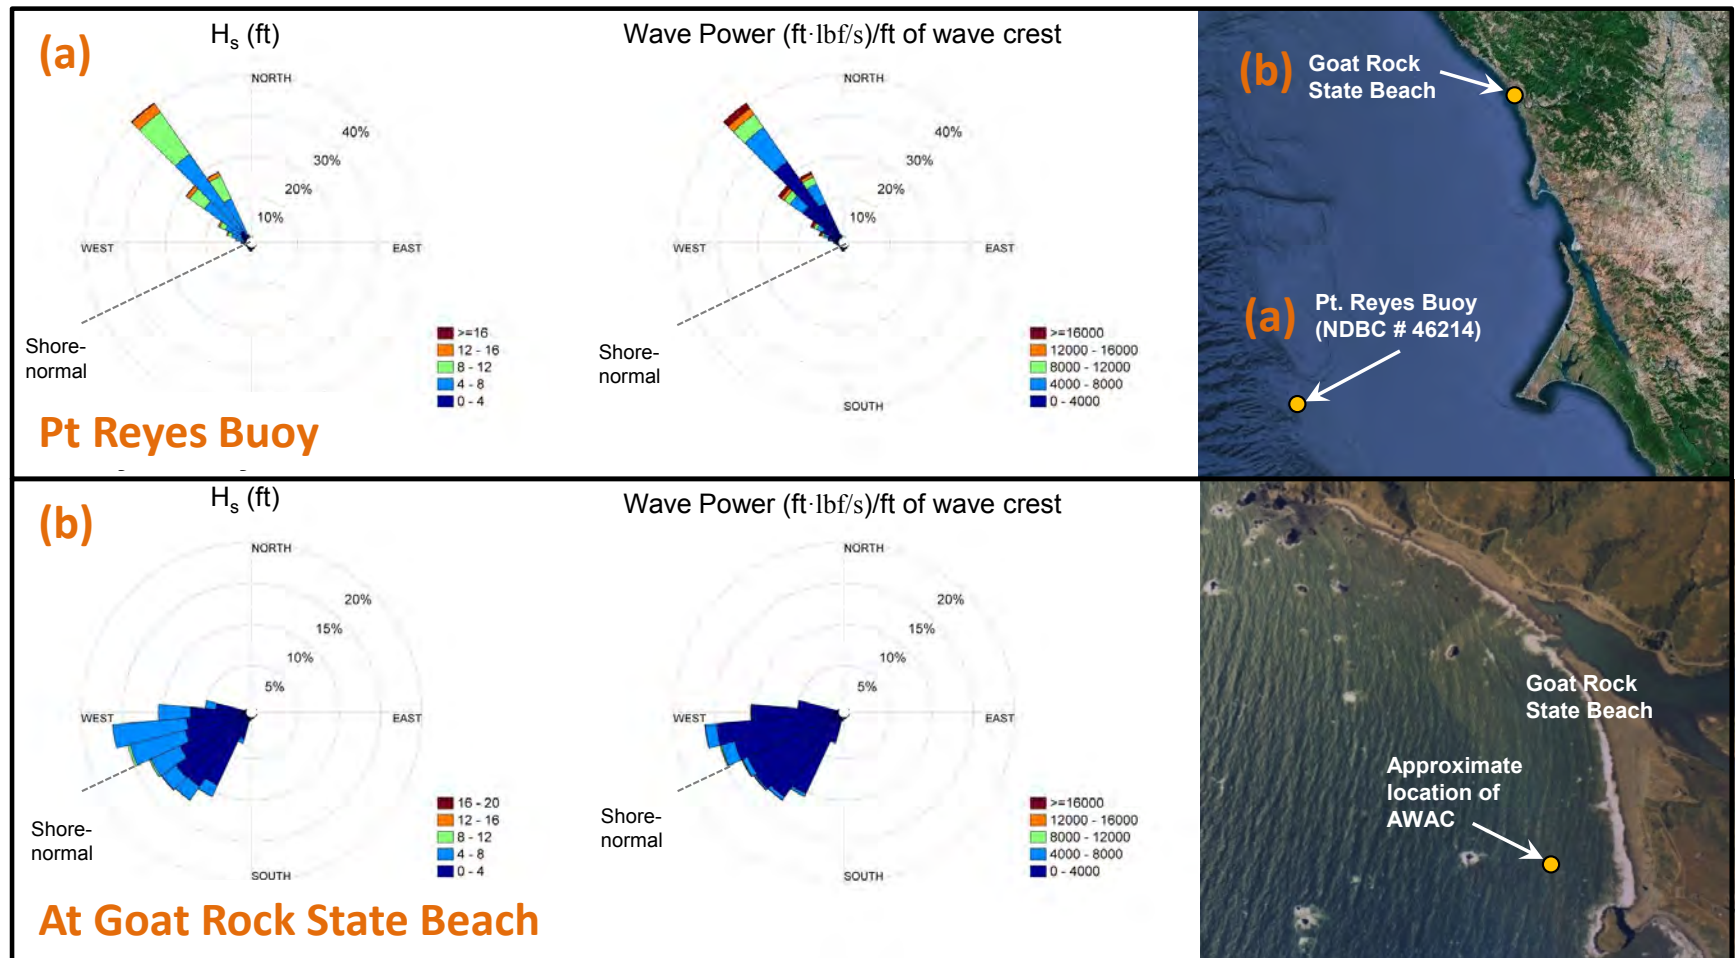
Comparison between dominant wave conditions at **(a)** the Pt. Reyes Buoy and **(b)** near Goat Rock State Beach.

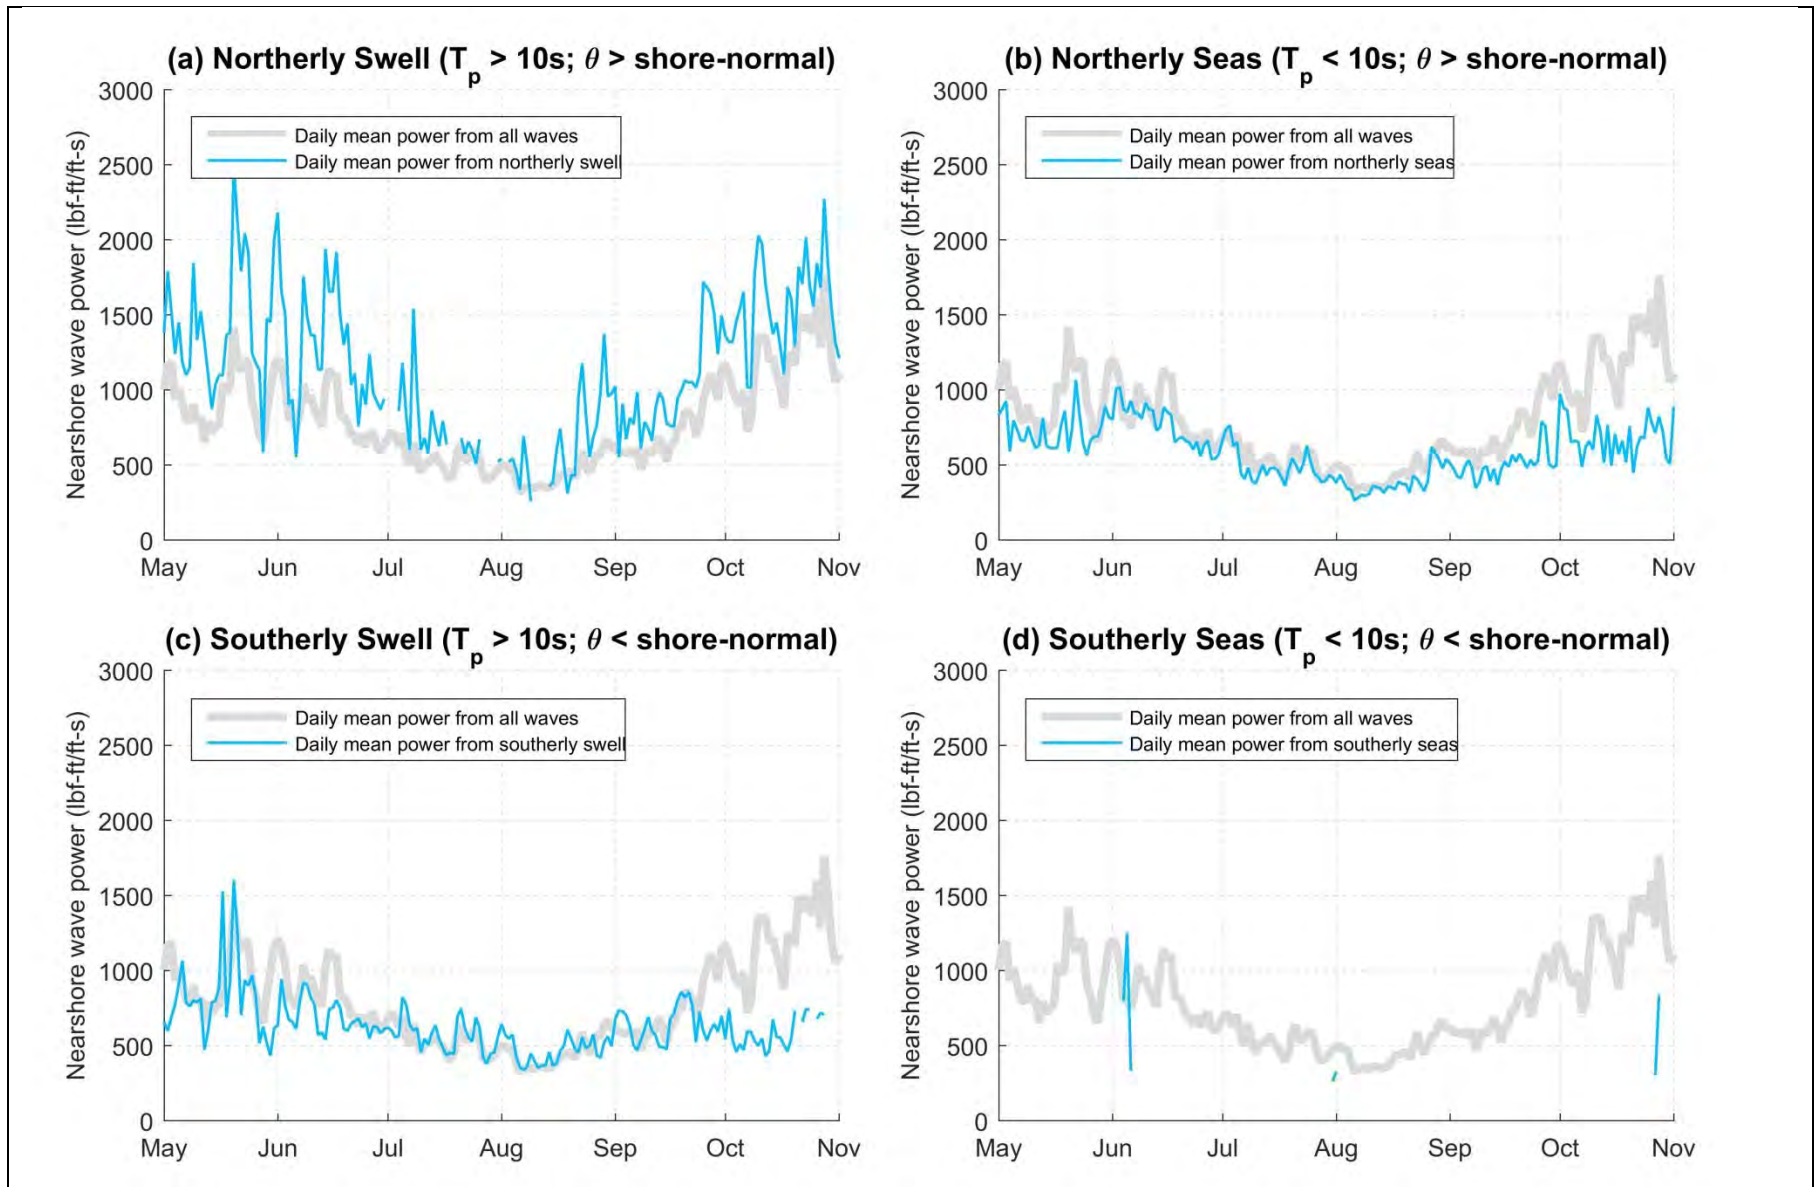
Daily aggregated measurements of nearshore predicted wave power grouped by northerly and southerly swells and seas.

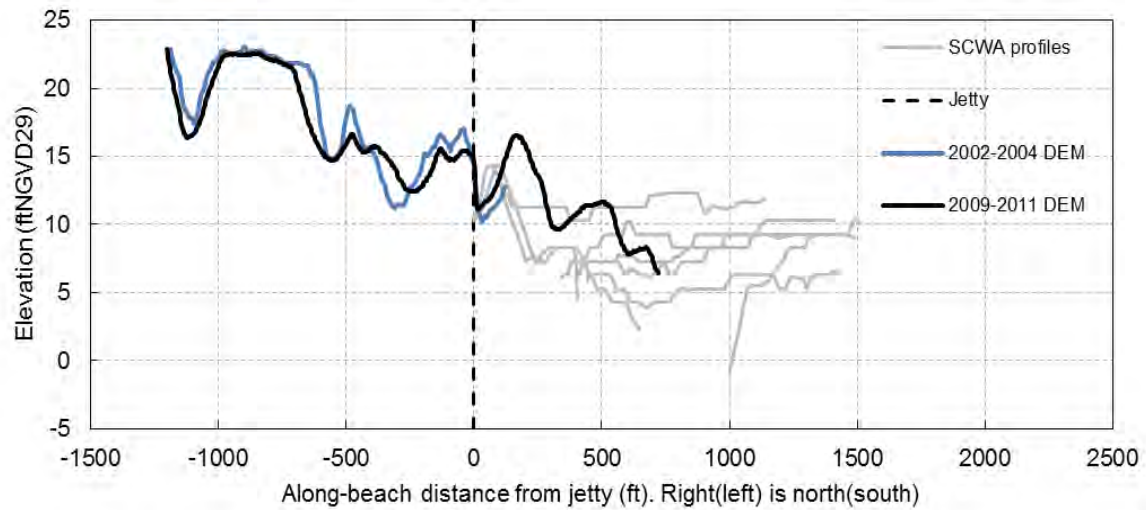
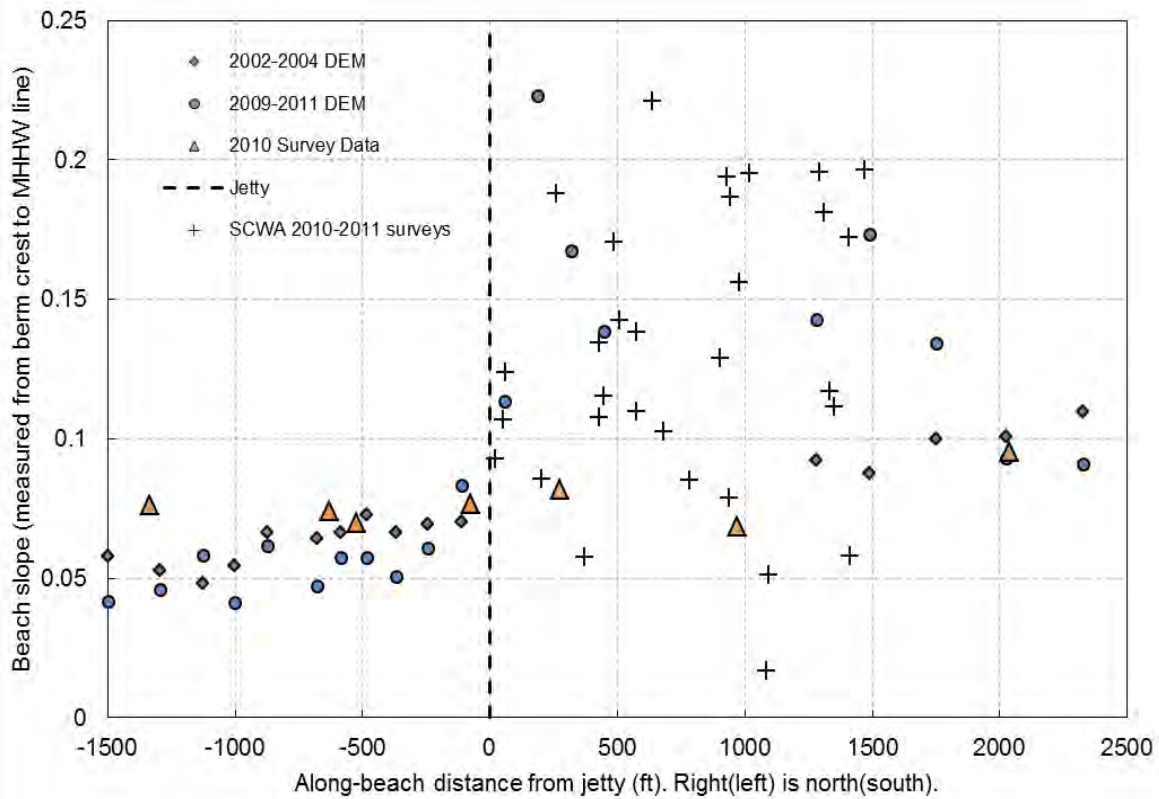
**Figure 4-6**

Distribution of alongshore component of wave power vector at the jetty groin location.

NOTE: Dashed line represents the point on GRSB where the seaward endpiece of the jetty groin is located. Beach slope was measured between MHHW and MSL.

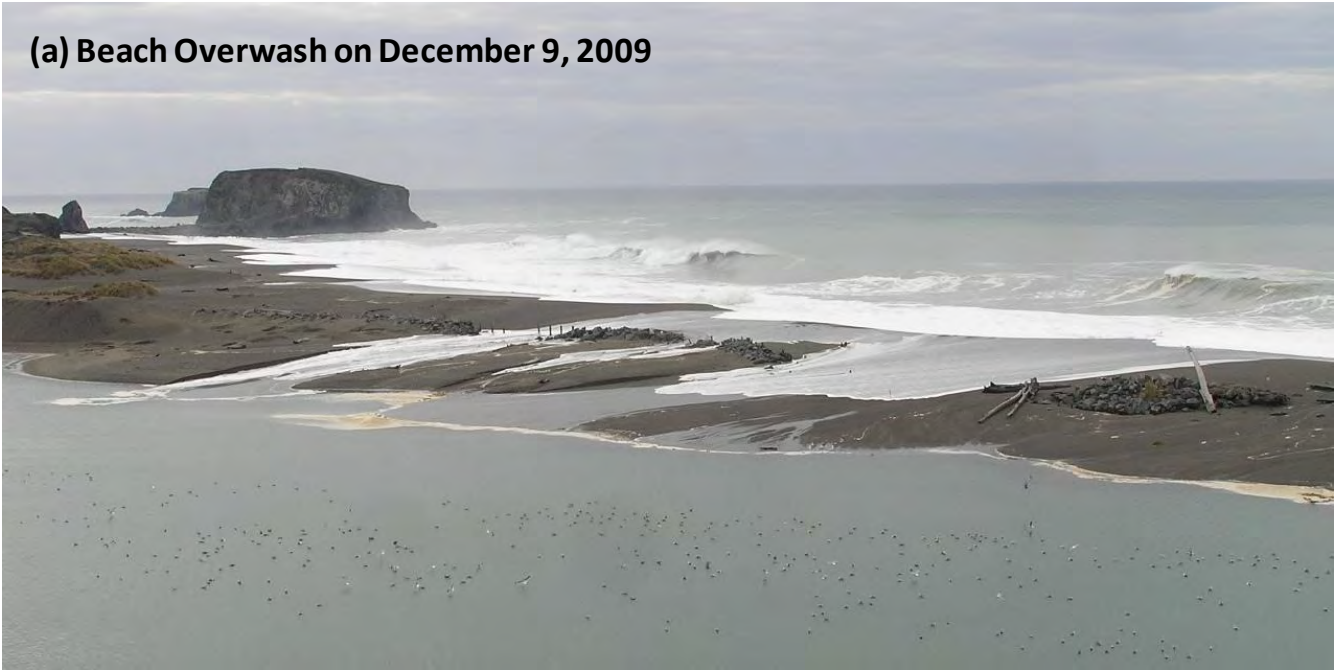
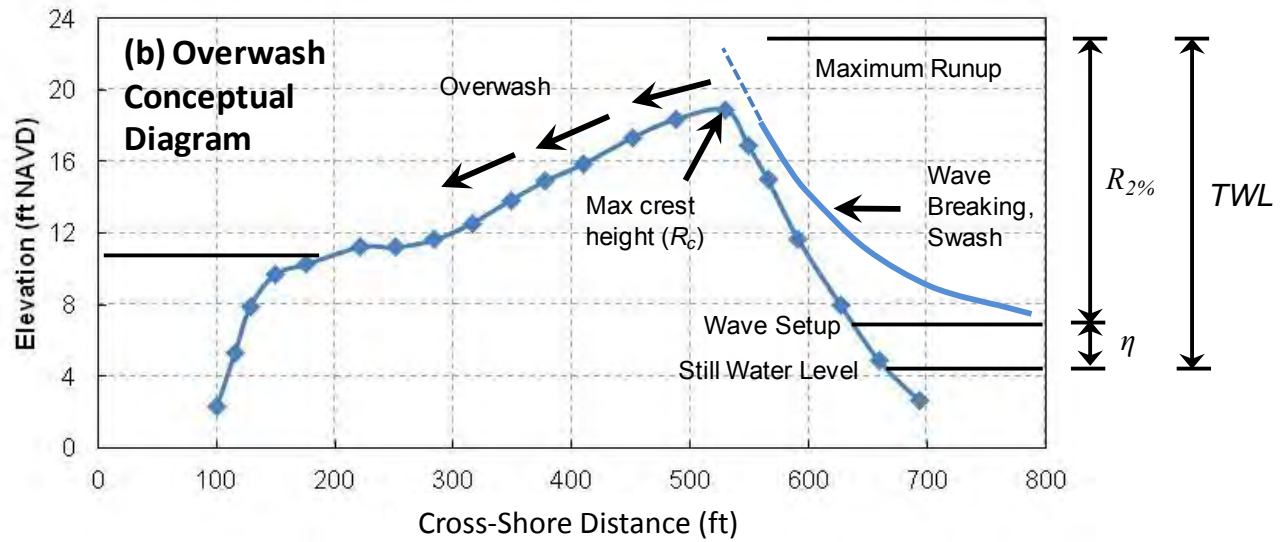
**Figure 4-7**  
(a) Along-beach crest profile of GRSB and (b) foreshore beach slope

**(a) Beach Overwash on December 9, 2009**

SOURCE: Photo credit in (a): Peter Baye. Beach profile in (b) taken from survey data from August 9, 2009 by Behrens (2012).
